Worldwide repairs carried out with PolymerMetal®

## Technical Report PolymerMetal®

### TEC-# 003

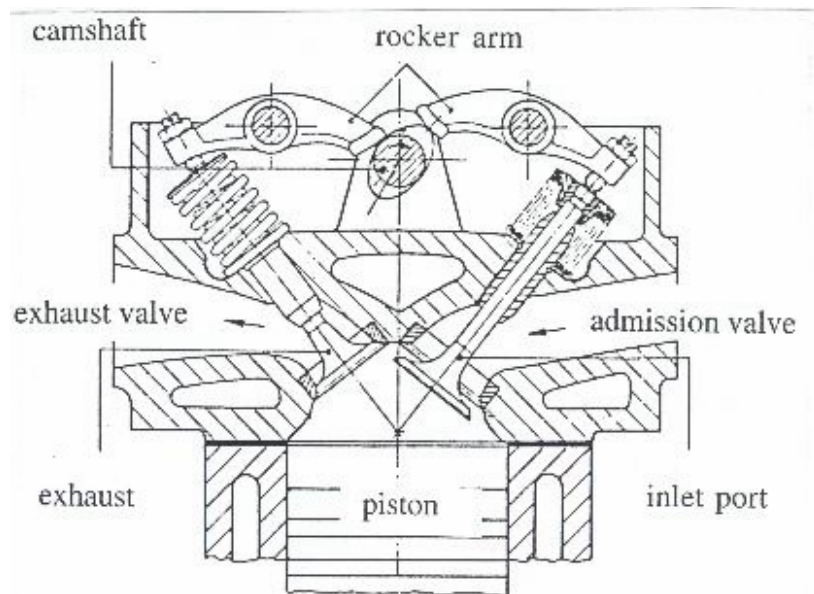
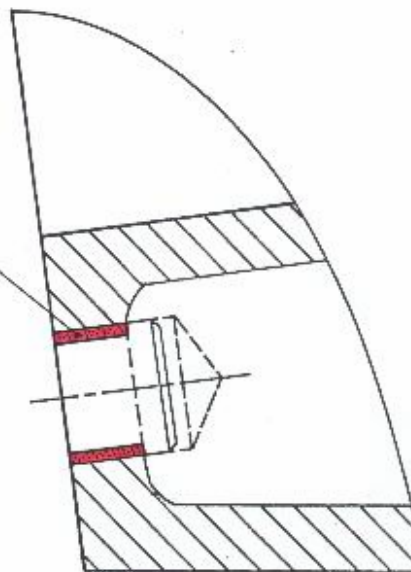
REP-# 103

With VP 10-500 a non-sealant vent plug in a cylinder head at an exhaust port was repaired. VP 10-500 was applied in a thickness of appr. 3 mm. Afterwards the plug seals remained gas-proof in spite of high operating temperatures of 300 °C.

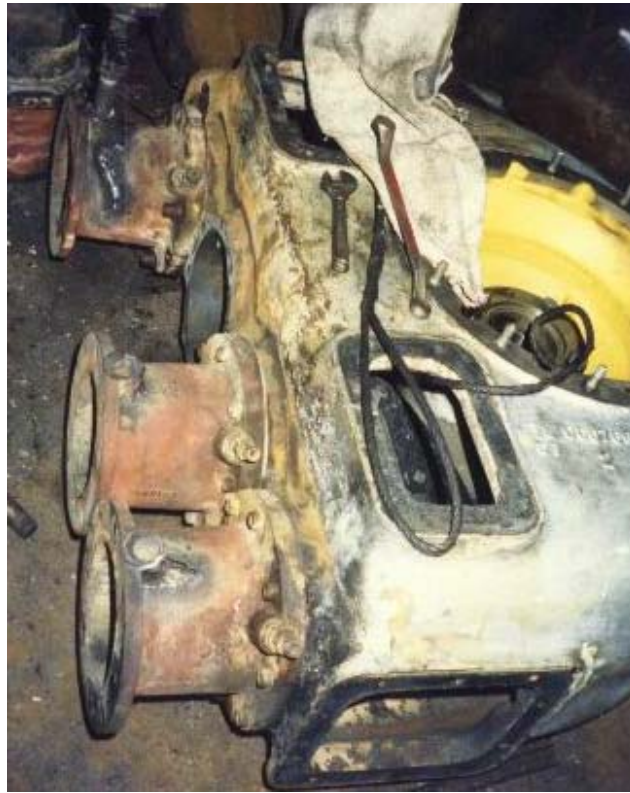
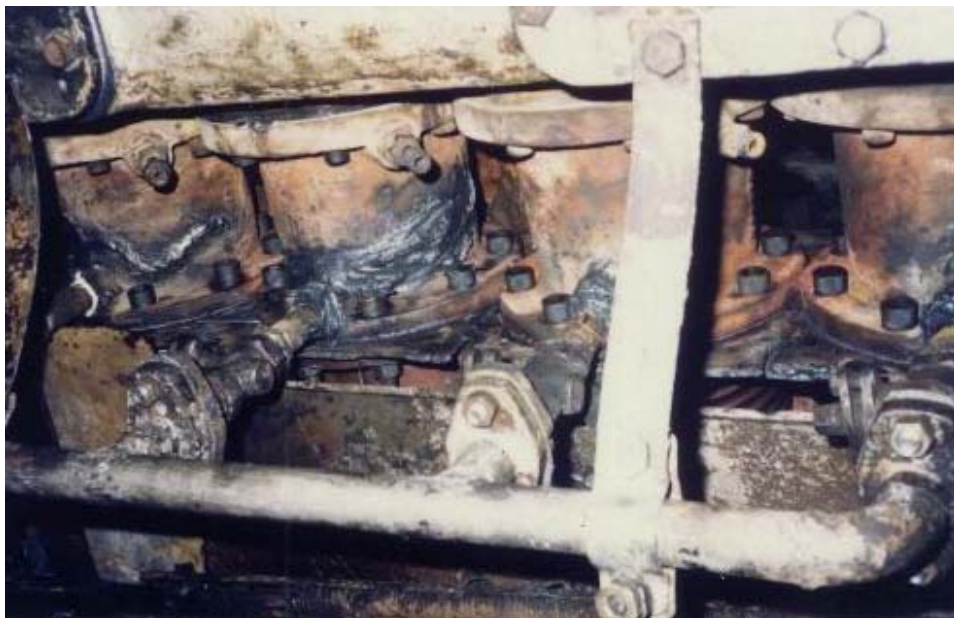
REP-# 122

Repair of a turbo charger using MM-metal SS-steelceramic. Today MultiMetall recommends the newer product VP 10-500.

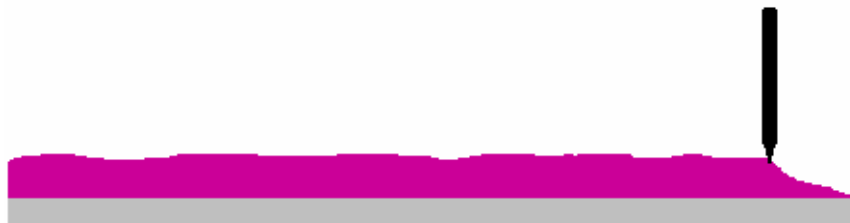
Finally a destructive test with hammer and chisel was done

After the destructive test only the structure of VP 10-500 was destroyed. The bonding on the steel remained constantly excellent.
